Bond Degradation and Reduced Cover in Concrete with Transverse Reinforcement

Michele Win Tai Mak, Janet M. Lees

Department of Engineering,
University of Cambridge,
Civil Engineering Bldg, 7a J.J. Thomson Ave, Cambridge CB3 0FA, United Kingdom

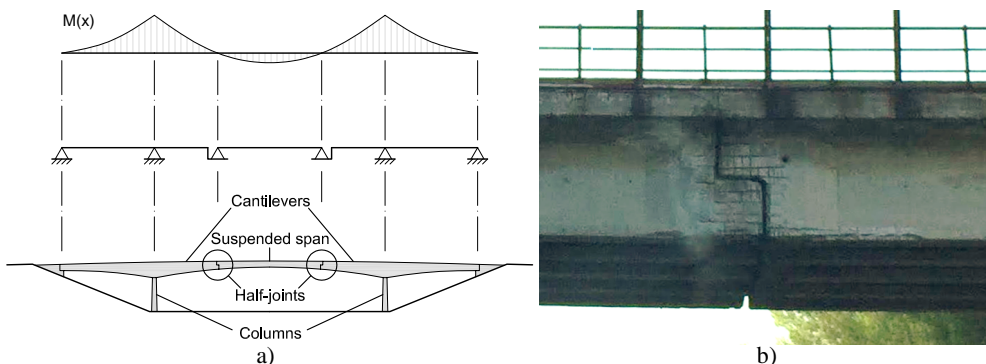
Fig. 1 Reinforced concrete half-joints: a) Typical double cantilever bridge (Gerber system) and associated static scheme; b) Corrosion-induced spalling of a half-joint bridge in Italy.

A critical category of infrastructure is the half-joint bridge [1]–[6]. Half-joints, also called dapped-ends, are a recurring support configuration in concrete bridges. They are characterised by a sudden reduction in depth at the support end of a structural element. A typical static scheme is indicatively shown in Fig.1.a. The advantages for design and construction in Gerber-type (or double cantilever) systems have justified their widespread use in the past. However, there are concerns associated with

this joint. Firstly, the complex distribution of internal forces was not well understood in the past. Superseded code provisions led to inadequate reinforcement and detailing. A common problem is leakage of contaminated water from above, which leads to corrosion of the internal steel bars. Reinforcement corrosion has several structural consequences. It causes a reduction in cross section of the bars. The expansive nature of corrosion products induces pressure that can lead to cracking, delamination or complete spalling of the concrete cover, as shown in Fig. 1.b for a deteriorated half-joint. Concrete cracking is particularly detrimental for the anchorage of the reinforcement [7], before the reduction in steel cross section becomes problematic. In half-joints in particular, the anchorage of the bottom bars is vulnerable to deterioration. Since the support is moved from the full-depth to the nib, the anchorage zone of the bottom tension reinforcement does not see the beneficial confining effect of the transverse support reaction [6], which can be seen as external ‘active’ confinement locally enhancing bond performance. Instead, in the anchorage zone of half-joints only the ‘passive’ confinement of the transverse reinforcement is present. This is schematically shown in Fig. 2. The combination of all the above mentioned deterioration phenomena leads to a reduction in load-carrying capacity that is difficult to assess in existing half-joints. Experimental evidence is therefore necessary to develop accurate assessment theories and models.

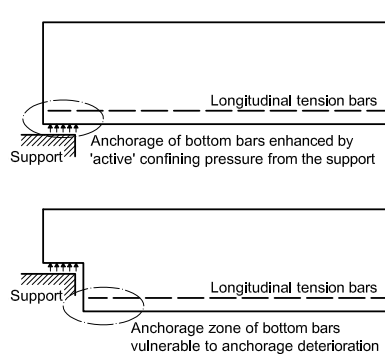
Fig. 2 Confining effect of direct support pressure on the anchorage of bottom longitudinal bars. Difference between conventional support arrangement and half-joint configuration.

- In half-joints, the underside of the full-depth section does not benefit from the external confinement of direct support pressure. Longitudinal tension bars are therefore vulnerable to anchorage deterioration;

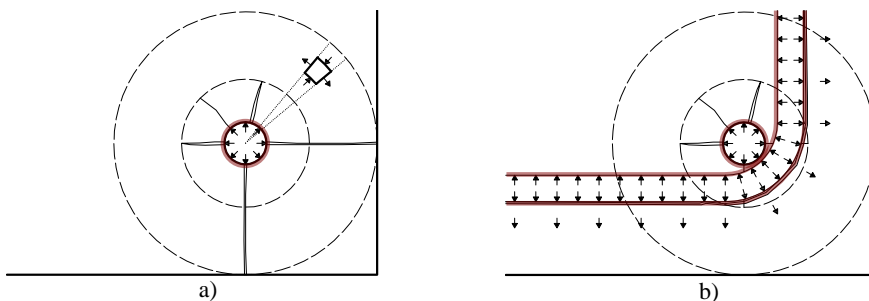
Fig. 3 Corrosion-induced expansions on the underside of a generic reinforced concrete element (images are indicative): a) 2D Thick Walled Cylinder analogy for pressure due to longitudinal bars only, in the absence of transverse reinforcement; b) 3D pressure distribution due to simultaneous corrosion of longitudinal and transverse bars.

Recent studies [7] suggest that for plain concrete, corrosion-induced crack widths could be good indicators of bond degradation, leading to better predictions than those based on degree of corrosion (such as mass loss or attack penetration). This is based on the assumption that cracks mainly develop radially, from the longitudinal bars towards the surface, as shown indicatively in Fig. 3.a. However, when transverse reinforcement is present, both longitudinal and transverse bars are subjected to corrosion. Cracks that are visible on the concrete surface are partially due to corrosion of the stirrups and their influence on the bond of longitudinal bars is more complex (see Fig. 3.b). The approach adopted in this study was therefore to investigate the extreme scenario where severe corrosion has led to complete delamination and spalling of the concrete cover. From an assessment perspective, this would lead to conservative results and estimates close to a lower bound.

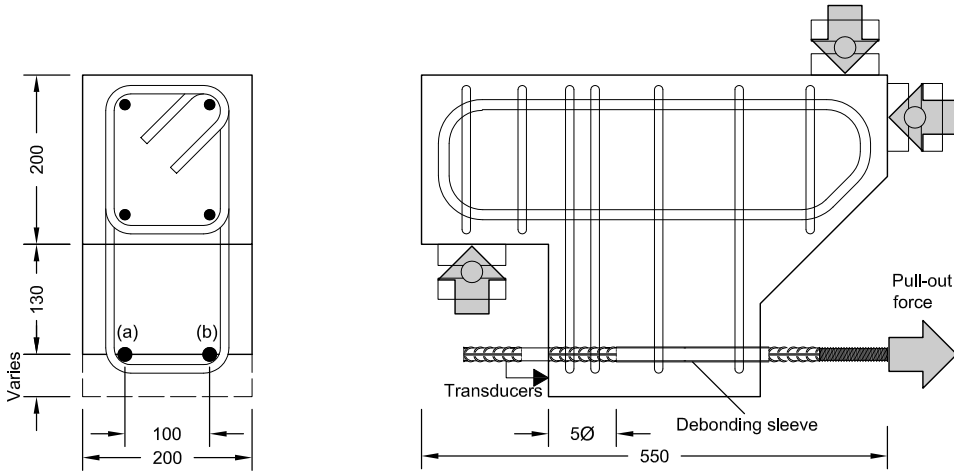
Bond pull-out tests were performed on eccentric half-joint cantilever specimens with progressively reduced cover. The geometry of the specimens and reinforcement layout are shown in Fig. 4.

Fig. 4 Geometry of eccentric bond test specimens with reduced bottom cover (dimension varies) to simulate corrosion-induced spalling.

On each specimen, 2 bars were tested sequentially in pull-out, for a total of 36 experiments. Three nominal sizes were used for the pull-out bars (10, 12 and 16 mm). Five progressively reducing values were adopted for the axis distance ($a = 50, 35, 25, 20$ and 0 mm), defined as the dimension between the external concrete surface and the centroidal axis of the longitudinal bars. This dimension is effectively equal to sum of the concrete cover and half the bar diameter ($a = c + \phi/2$). In the specimens where the longitudinal steel bars were exposed, the cover therefore had a negative value. Different combinations of bar diameter and axis distance allowed for the cover-to-diameter ratio c/ϕ to be adopted as a key parameter in the study. The bonded length was equal to 5 times the bar diameter in all specimens. The short embedment length was chosen to avoid premature failure of the steel in tension. This also justified the assumption of constant bond stresses along the bars in the analysis of the results. The same transverse confining reinforcement was adopted in all tests, consisting of two 8 mm diameter stirrups within the embedment length. The specimen naming convention consists of three numbers e.g.:

where the first number after the diameter symbol indicates the size of the longitudinal bar tested, the second number indicates the horizontal axis distance to the bar centreline measured from the concrete side face (fixed at either 25 or 50 mm) and the third number indicates the vertical axis distance measured from the bottom concrete face. The last lowercase letter indicates the first bar (a) or second bar (b) tested on a given specimen. All the reinforcement consisted of deformed high-strength steel bars with a nominal yield strength of 500 MPa. An Ordinary Portland Cement (OPC) mix was used in all the bond specimens. The average material properties obtained with standard characterisation tests at 28 days were $f_c = 24.2$ MPa (SD= 1.4 MPa) for 100 mm cubes and $f_{c,cub} = 26.5$ MPa (SD= 1.8 MPa) for 100 mm diameter and 200 mm long cylinders in compression. The average split tensile strength was $f_{ct,sp} = 2.17$ MPa (SD= 0.25 MPa) measured on cylinders of the same dimensions. Bond tests were also carried out 28 days after casting. The force was applied with a hydraulic jack and measured with a tension load cell. The slip of the bars relative to the face of the concrete was measured with two Linear Potentiometric Displacement Transducers (LPDTs) clamped on the passive (unloaded) side of the bars. The average of the two readings was typically used in the analysis of the results.

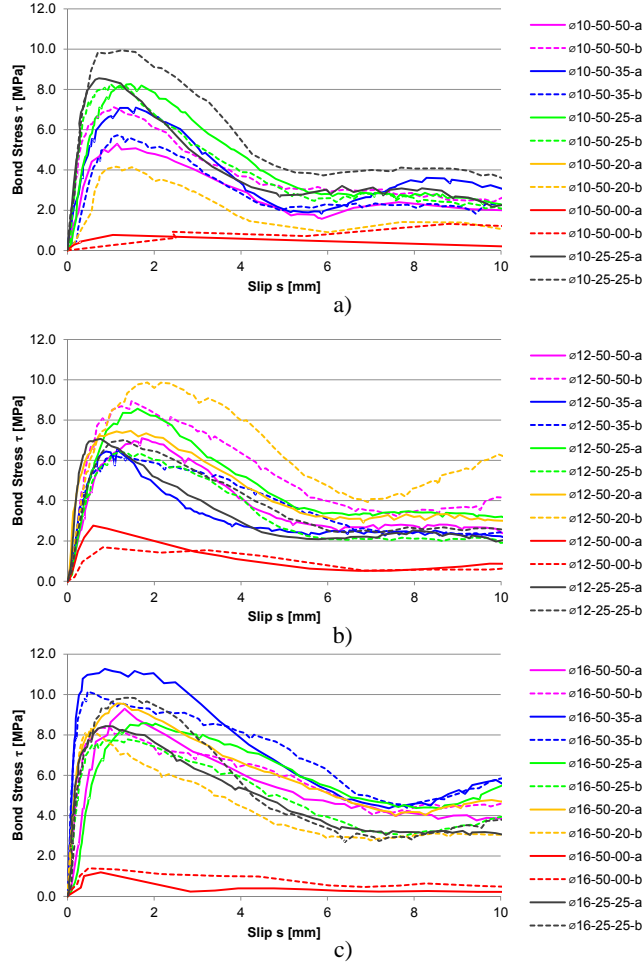
where F is the pull-out force, \varnothing is the nominal diameter of the bar, $l_{b,0}$ is the initial bonded length and s is the slip measured during the test. Fig. 5 shows the results of the pull-out tests. All the bond stress-slip curves are shown, grouped by bar size (respectively $\varnothing = 10, 12$ and 16 mm bars).

Fig. 5 Eccentric bond test results on half-joint cantilever specimens. Bond stress-slip pull-out curves for: a) $\varnothing = 10$ mm; b) $\varnothing = 12$ mm; c) $\varnothing = 16$ mm bars. Solid lines indicate test on the first bar (a) and dashed lines indicates test on the second bar (b) for a given specimen.

Specimens with high c/ϕ values failed by pull-out, whereas those with smaller c/ϕ failed mainly by splitting. However, the bond stress-slip curves showed that all tests exhibited a gradual post-peak decrease in resistance, even in the case of splitting failure. Sudden drops typically associated with brittle splitting failure in unconfined specimens were not recorded. With respect to the peak bond resistance, the results do not show a marked trend of reducing strength as the c/ϕ decreases from 4.5 to 0.75. However, a significant drop in resistance can be observed when the longitudinal bars are exposed to mid-barrel, corresponding to a negative $c/\phi = -0.5$. The cracking pattern of six significant specimens is shown in Fig. 7.

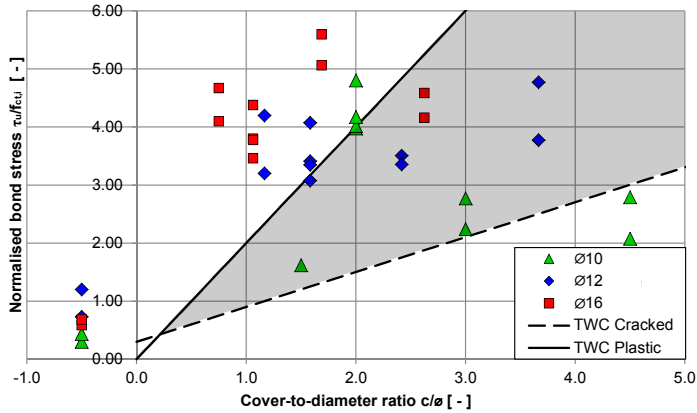
To compare the results for different dimensions and highlight the dependence on c/\varnothing , the nominal peak bond stresses for all bar diameters are plotted as a function of c/\varnothing in Fig. 6. The bond strength is also normalised with respect to the concrete splitting tensile strength to reduce the scatter in the results due to variations in concrete quality between specimens. The two curves in the plot indicate two analytical solutions based on a Thick Walled Cylinder formulation by Tefpers [13], where two con-

crete models in tension were used to obtain a lower and upper bound: brittle partially cracked (dashed line) and perfectly plastic (continuous line) respectively. The contribution of transverse reinforcement is neglected in the analytical formulation. The space between the two analytical solutions can be interpreted as a domain of possible intermediate results for unconfined concrete.

Fig. 6 Bond strength (peak stress) results from all tests, normalised by concrete splitting tensile strength. Dependence on c/ϕ and comparison with Thick Walled Cylinder analysis [13].

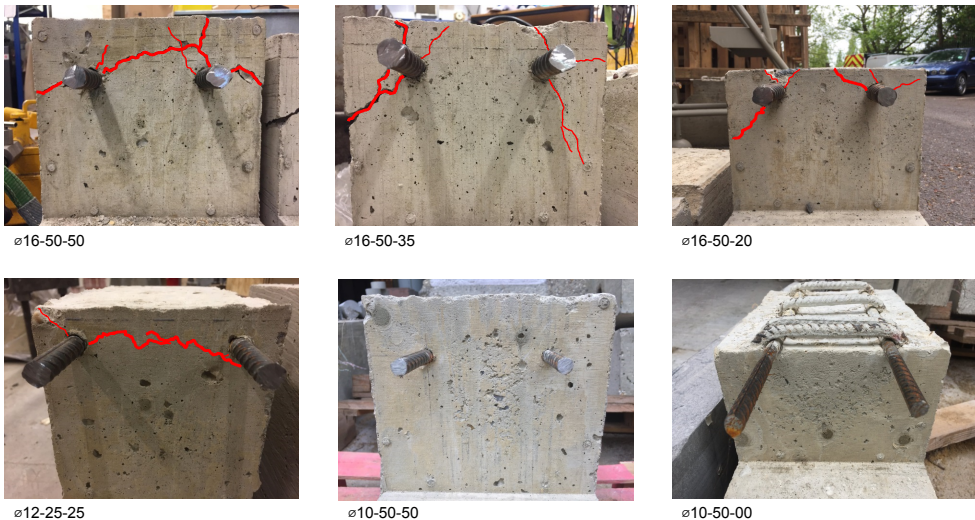
Fig. 7 Cracking pattern around the bars on the passive side of the specimens, after testing. Cracks are highlighted in red where present.

It can be observed that specimens with high values of c/ϕ did not exhibit surface cracking (such as $\phi 10-50-50$). For lower c/ϕ instead, the extent of cracks developed during the first and second pull-out tests overlap ($\phi 16-50-50$, $\phi 12-25-25$). In other specimens, the extent of cracked concrete around one bar and the other did not intersect ($\phi 16-50-35$, $\phi 16-50-20$).
